390
NBSIR 74-605

Crush Characteristics of Automobile Structural Components

Final Report

Prepared for
National Highway Traffic Safety Administration
Department of Transportation
400 7th Street, S.W.
Washington, D. C. 20590

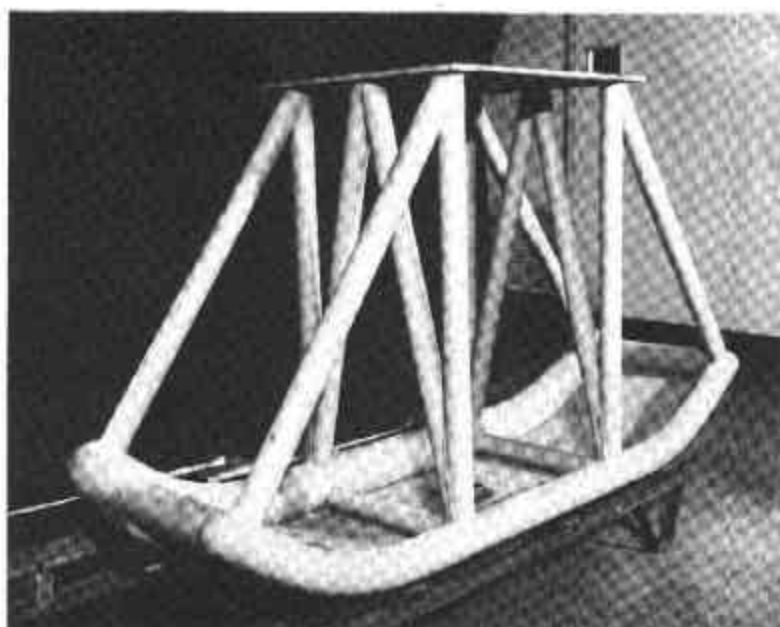
Figure 1 — SIMULATED BUMPER USED FOR STATIC CRUSH TESTS

The simulated bumper used for the static crush tests is shown in Figure 1. This design is essentially identical to that specified in the Society of Automotive Engineers (SAE) recommended practice for moving barrier collision tests, insofar as the contoured face is designated [3]. The SAE design was based on deformation considerations and observations of a wide range of side impacts from a wide range of vehicles. The support structure was designed so that all parts of the loading system would be rigid with respect to the structure to be crushed so that no yielding would occur in its components. The weight of the bumper in this configuration was about 800 lb (363 kg).

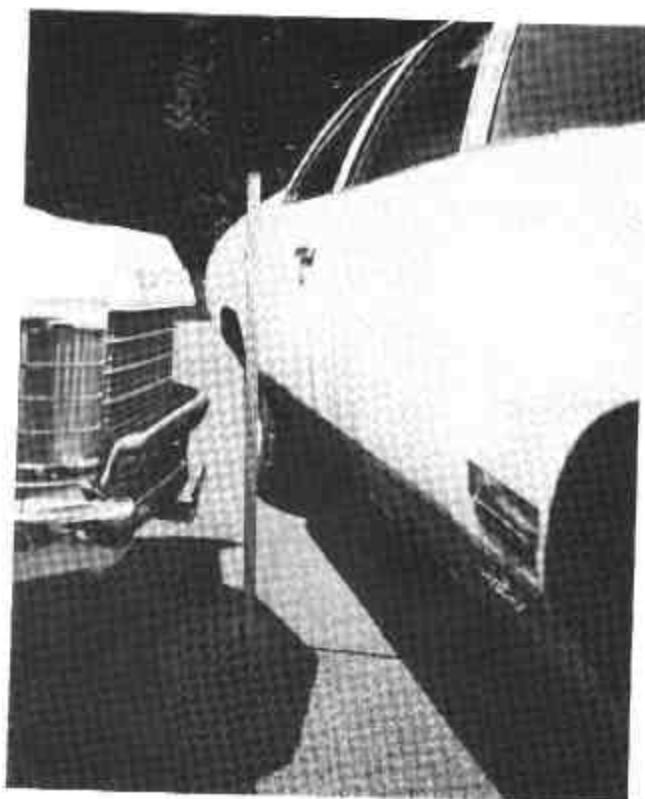
Figure 4 - RELATIVE POSITION OF BUMPER AND SIDE STRUCTURE FOR TWO SIMILAR VEHICLES

Alignment of the bumper relative to the SRP was chosen to achieve a deformed side structure profile which would be representative of the profiles generated in perpendicular side impact collisions [2]. In selecting the bumper alignment, it is useful to measure the relative position of the front and side structure of two vehicles having the same design and weight, such as shown in Figure 4. After considering these factors, it was decided to align the axis through the center of the top edge of the steel band incorporated on the bumper face with the horizontal axis through the SRP, and aligning the center of the bumper with the vertical axis through the SRP location. This alignment was checked by use of plumb bobs which were suspended from the bumper after it was connected to the sensitive crosshead of the testing machine and the vehicle and test frame were moved onto the machine platen. After alignment of the vehicle relative to the bumper was completed, the test frame was rigidly connected to the tie down points available in the platen.

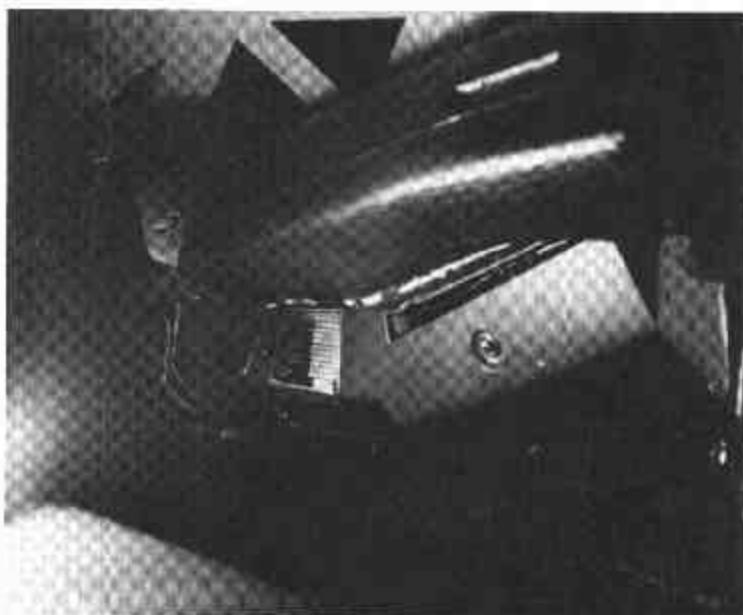
Figure 30 — BUCKLING DEVELOPED IN DASH DURING STATIC CRUSH TEST OF VEHICLE "A"

Considerable buckling occurred across the dash during the test of the Vehicle "A" right side, as shown in Figure 30. Since no significant deformation of the dash was observed for loads up to 15,000 lbf (66.7 kN), the dash buckling developed somewhere between this load and the maximum applied load of 20,000 lbf (89.0 kN). The deformation which initially occurred in the middle of the dash precipitated a fracture at the base of the windshield adjacent to the dash, and the large deformations which occurred later caused fracture of the front glass adjacent to the A pillar.

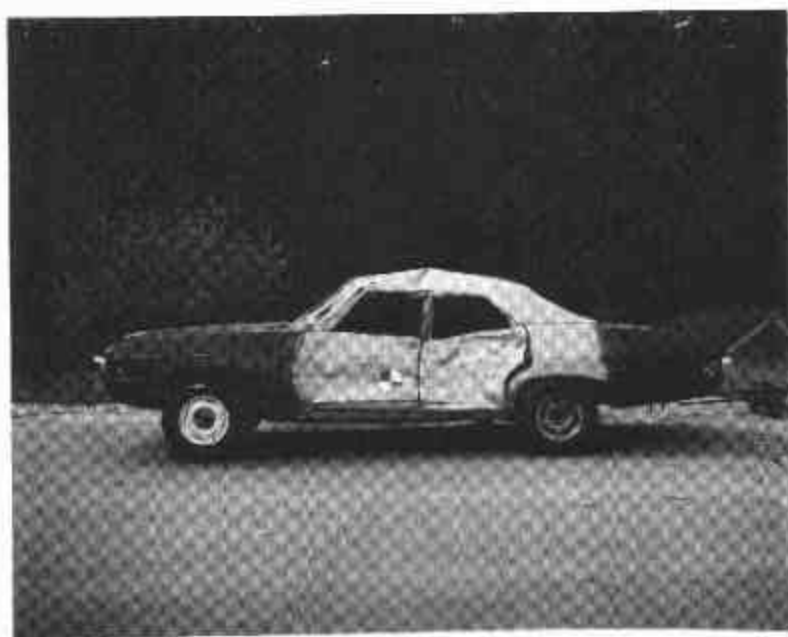
Figure 34 - EXTERNAL SIDE DEFORMATION AFTER STATIC TEST OF VEHICLE "B-1"
[UPPER] AND DYNAMIC TEST OF VEHICLE "B-2" [LOWER]

Several methods can be employed to compare the static and dynamic crush test results. Figure 34 shows the overall damage incurred in the side door structure during the static test of Vehicle "B-1" and the dynamic test of Vehicle "B-2". A plot of the exterior deformation of the vehicle left side after the two tests is shown in Figure 35. An examination of the permanently deformed rear door side guard beam after the drop test for Vehicle "B-2" is shown in Figure 36, which can be compared with the corresponding damage produced during the static crush test of Vehicle "B-1" which was shown in Figure 32.
